August 25, 2010

Re: Gull Bay Road Extension Culvert

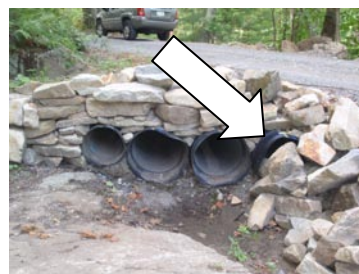
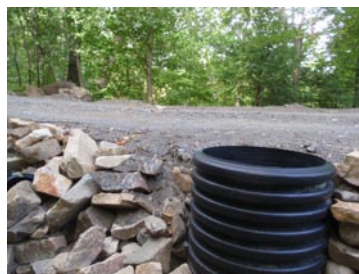
Culvert & Emergency Overflow Inlet:

4 culverts [(3) 24" and (1) 12" corrugated HDPE pipes] are installed for primary conveyance of runoff and will direct flow to the south. There is an emergency overflow provided consisting of a 24" corrugated HDPE with a 90°elbow and raised outlet.

- The western 24" culvert inlet is blocked by rip rap that creates an entrance problem. This will restrict flow and increase the potential of the road washing out.
- The elevation of the 24" emergency overflow appears to be level with the existing road. This will result in water flowing across the road instead of being conveyed through the culvert creating erosion and sedimentation problems.

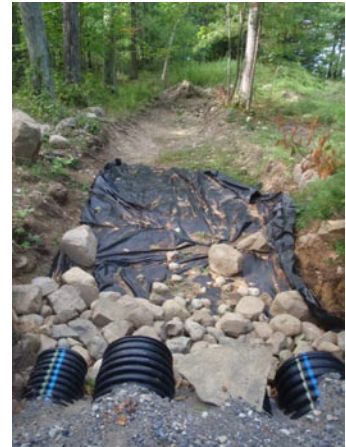
Culvert Outlet:

The (4) main channel culverts discharge to the south to a partial stone and earthen channel with filter fabric. Construction is incomplete and inadequate.

- The stone outlet protection appears to be incomplete. This will fail to adequately reduce outlet velocities and will result in the potential for erosion and sedimentation.
- The lower portion of the earthen channel is unprotected resulting in the potential for erosion and sedimentation.
- The outlet channel does not appear to be completely excavated to allow free discharge. This will result in ponding and further potential of erosion.

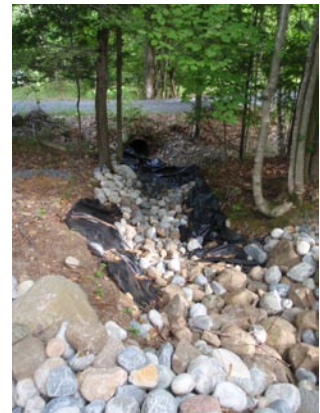
Emergency Overflow Outlet:

The 24" emergency overflow discharges to the existing channel from the removed culvert where significant erosion existed. Filter fabric has been installed on the upper section immediately downstream of the discharge. Stone channel protection has been partially installed. There is no bare earth exposed limiting the potential for erosion.

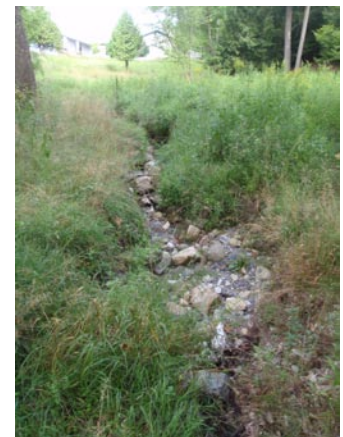
No stabilization or restoration work has been performed on the downstream channel section that discharges to Lake George. Existing sediment remains in the channel. The channel should be laid back to provide a greater surface area that will reduce velocity and the potential for further erosion.
