Re: Blue Lagoon Resort – 3670 Lake Shore Drive (225.12-1-15)
Site Plan #2-2009

The Lake George Waterkeeper has reviewed the revised submission for the above referenced site plan review application. The Waterkeeper recognizes the site constraints referenced by the applicant and their recommendation for non-infiltrative controls to better fit the limiting conditions. However, the stormwater management system could be improved for a large parking area where the proposed stormwater controls do not conform to the Town of Lake George regulations. The Planning Board should also determine if a variance is required for the project. The Waterkeeper offers the following comments:

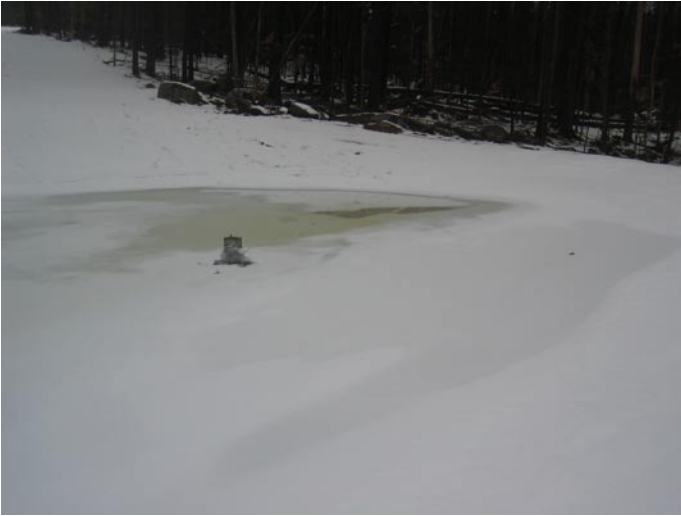
Photograph of wet pond - Town of Hague subdivision taken on January 30, 2008. Note the freeboard height of the standpipe above the ice elevation.

The New York State Stormwater Design Manual recommends an additional foot of freeboard in wet/pocket ponds to account for ice buildup in cold climate conditions. These stormwater controls become ineffective during the winter months where rain events occur more frequently. Also, the ice could build up to block the discharge pipe inside the basin. Attached are photographs of wet/pocket ponds in the Lake George watershed depicting significant ice buildup which significantly reduces the volume available for stormwater management and treatment.

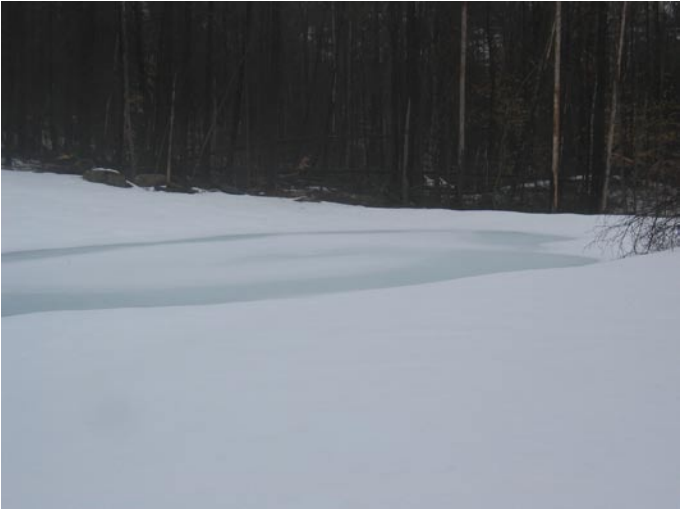
Photograph of same wet pond – Town of Hague subdivision taken on March 20, 2008. Note that there is no freeboard on the standpipe above the ice resulting in direct discharge of runoff without management or treatment.

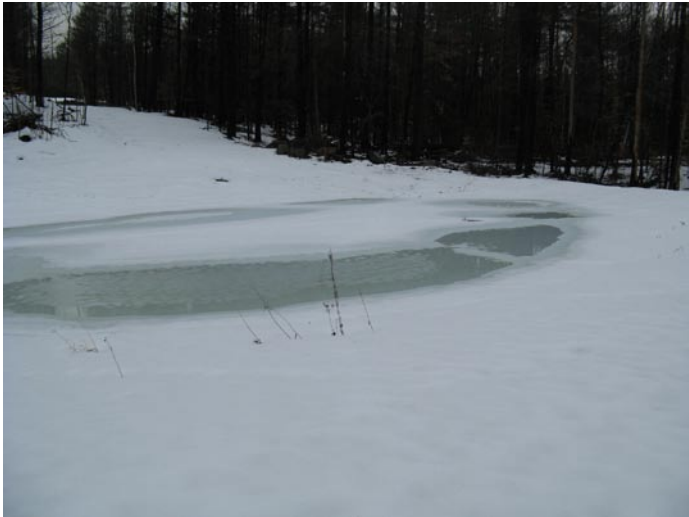
Photograph of same wet pond taken on March 11, 2009 during rain event. Note the lack of freeboard on standpipe resulting in direct discharge of runoff during rain event show in adjacent photograph.
