LAKE • GEORGE
WATERKEEPER®

Re: Blue Lagoon Resort (225.12-1-15)
AV 28-2009

ADVERSE IMPACTS TO THE ENVIRONMENT

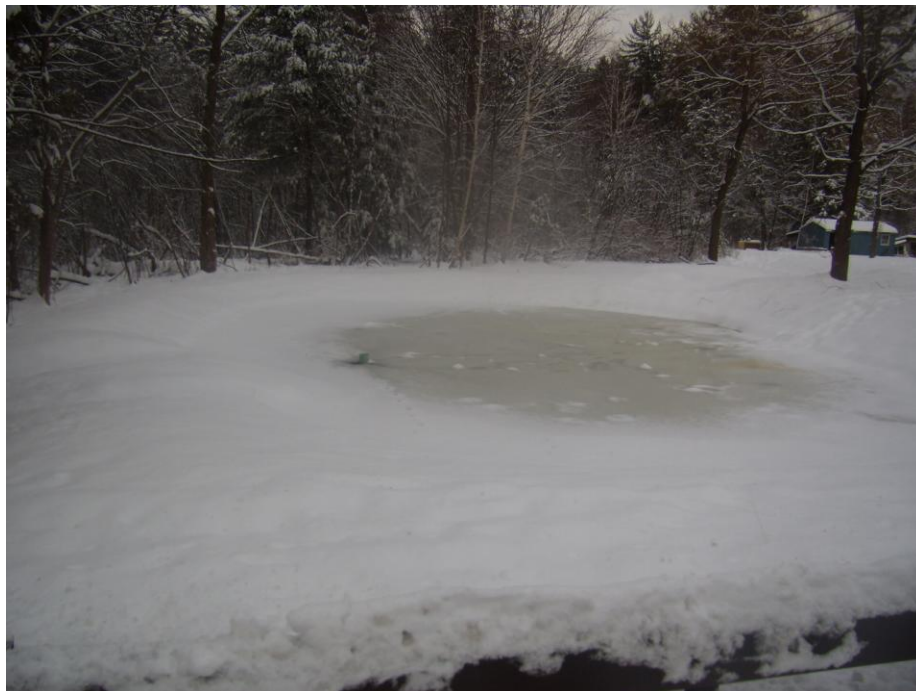
The Blue Lagoon Resort site plan for the parking lot and stormwater management system was approved by the Town of Lake George Planning Board on June 9, 2009. The stormwater management plan consisted of a wet pond with approximately 2.4 feet of freeboard between the permanent pond elevation and the emergency spillway. The discharge for the pond was a 6" pipe located approximately 10" above the permanent pool elevation. However, the wet pond currently has been altered with a standpipe in the middle of the pond that raises the permanent pool elevation. Currently the permanent pool elevation (which is frozen) is approximately 6" below the emergency spillway elevation.

Photograph of wet pond constructed at the Blue Lagoon Resort. Note the standpipe on the left side of the pond and the ice elevation which reduces the ability for stormwater management.

The Lake George Waterkeeper recommends the Town of Lake George Zoning Board of Appeals condition the variance with a requirement for further review of the stormwater management facility, specifically to require a certification of construction and evaluate increasing the level of stormwater treatment and management. This will increase water quality from the impervious surfaces located adjacent to tributary in close proximity to Lake George.

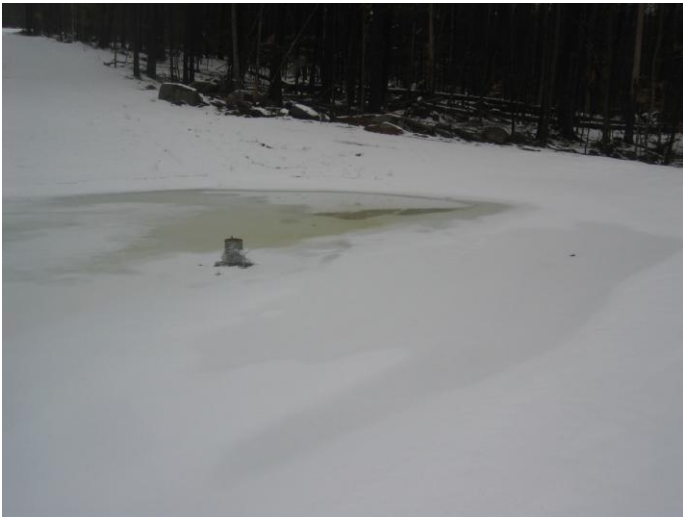
Photograph of wet pond - Town of Hague subdivision taken on January 30, 2008. Note the freeboard height of the standpipe above the ice elevation.

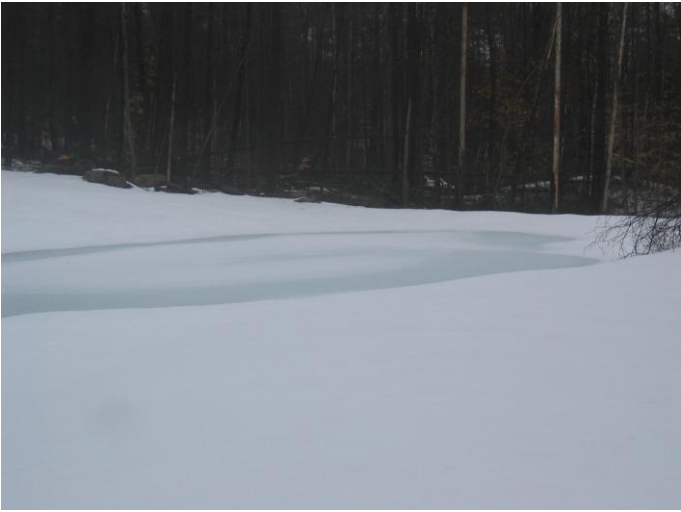
Photograph of same wet pond – Town of Hague subdivision taken on March 20, 2008. Note that there is no freeboard on the standpipe above the ice resulting in direct discharge of runoff without management or treatment.

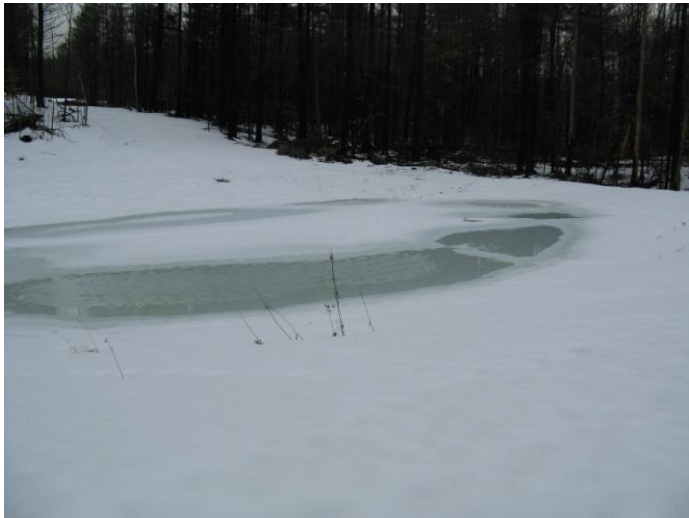
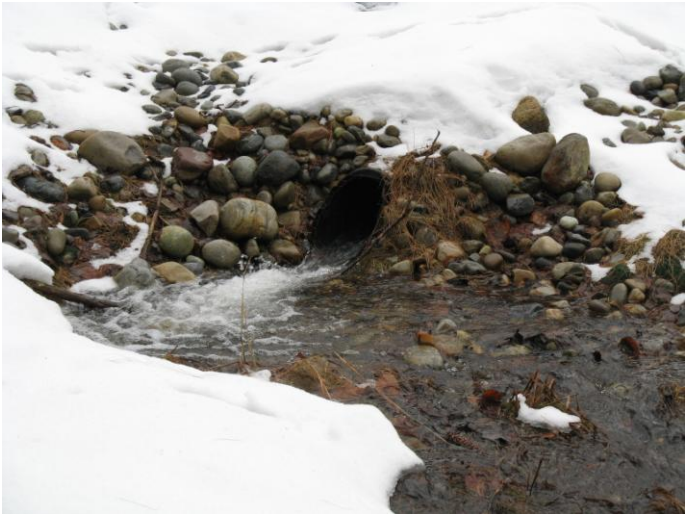
Photograph of same wet pond taken on March 11, 2009 during rain event. Note the lack of freeboard on standpipe resulting in direct discharge of runoff during rain event show in adjacent photograph.
